INDONESIA

General

Existing polders

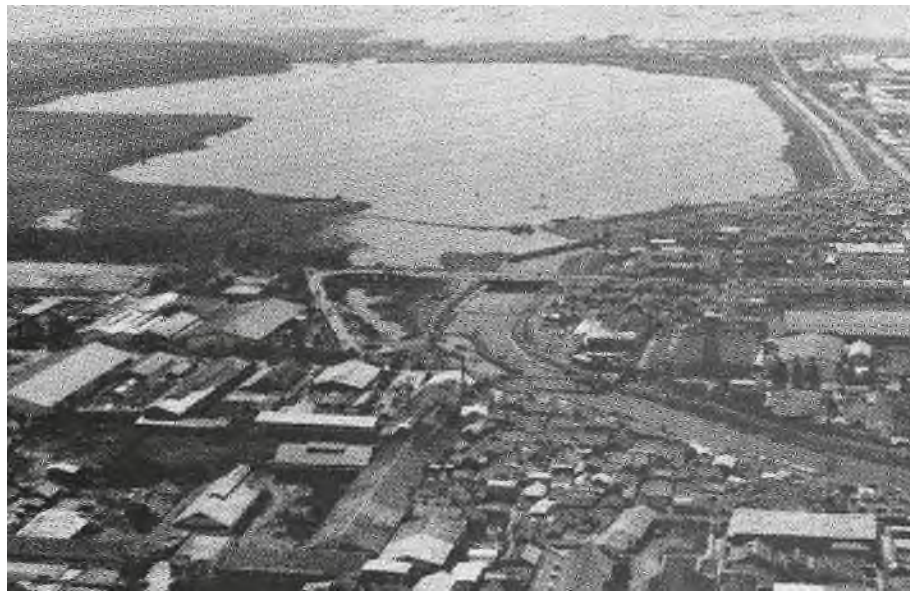
- * for storage within the Pluit polder a reservoir of 83 ha (3% of the polder area) has been constructed (Figure 2). Kop *et al.* (1983) give the design criteria for the water level in the reservoir under the conditions of 1/25 years. These are: in the wet season P.P.¹ -1.90 m and P.P. + 1.00 m. During the wet season a minimum water level of P.P. -1.00 m;

Figure 2. Aerial view of the storage reservoir and waterworks in the Pluit Polder (Kop *et al.*, 1983)

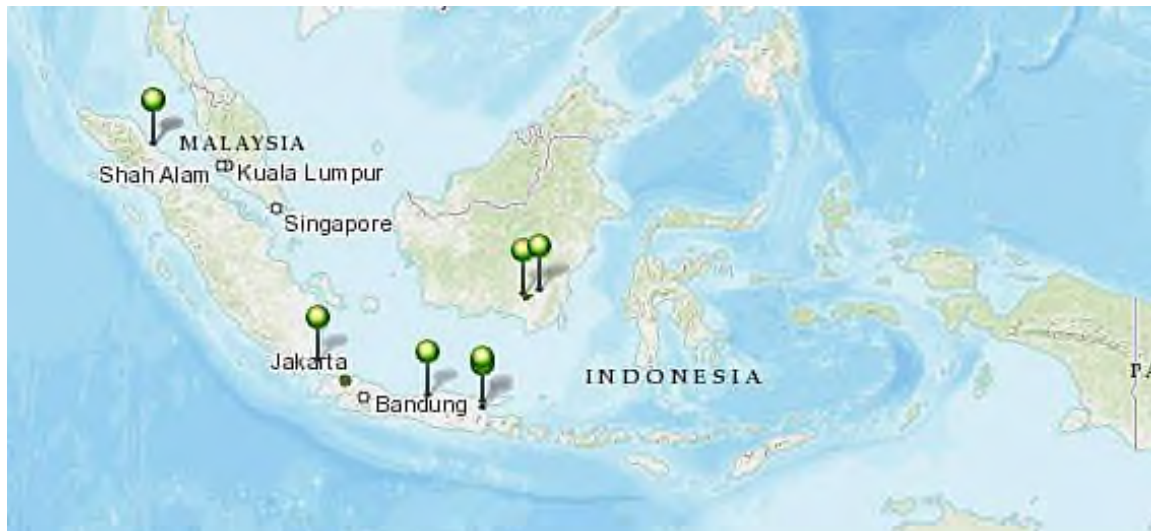
The location of the polders in Indonesia is shown in Figure 5.

Figure 5. Location of the polders in Indonesia (source: esri – Batavialand)

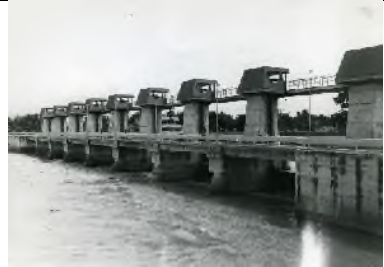
A2 058/I.2.58 Lengkon distribution structure apex of the Kali Brantas delta in East Java	A6 003/1.6.3 Banjarmasin, Delta Pulau Petak, South Kalimantan. February 1977	A6 004/1.6.4 Banjarmasin, Delta Pulau Petak, South Kalimantan. February 1977	A6 006/1.6.6 Barambai, South Kalimantan. February 1977

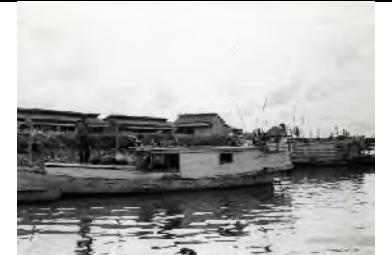
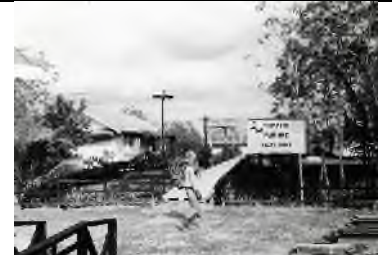
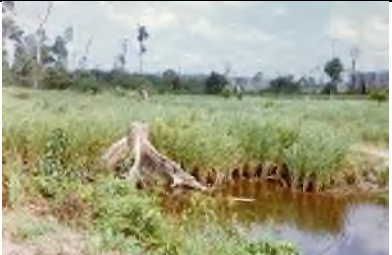
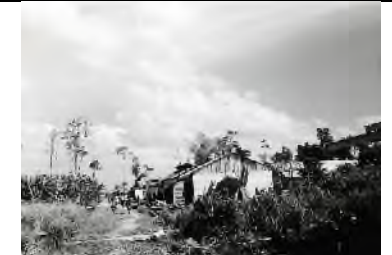
A6 027/I.6.27 Delta Upang, Primary canal 2, South Sumatra. February 1977	A6 032/I.6.32 Delta Upang, Primary canal 2, South Sumatra. February 1977	A6 034/I.6.34 Delta Upang, Primary canal 2, South Sumatra. February 1977	A6 035/I.6.35 Delta Upang, Primary canal 2, South Sumatra. February 1977

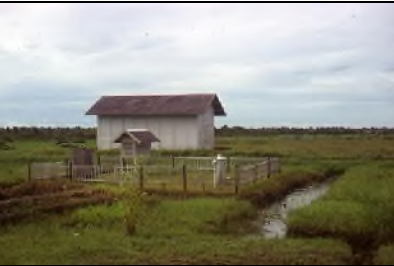
D3 4 041/D.3.4.41 Hydrological station in Lowland area	D3 4 044/D.3.4.44 Bridge over primary canal	D3 4 045/D.3.4.45 Culvert and staff gauge in tertiary canal	D3 4 046/D.3.4.46 Bridge over secondary canal

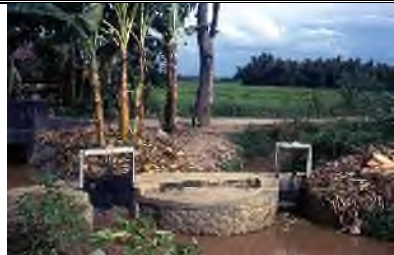
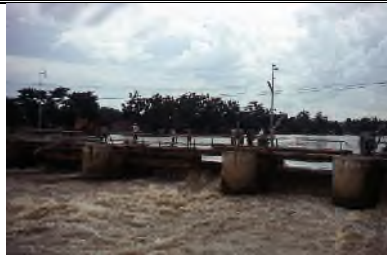
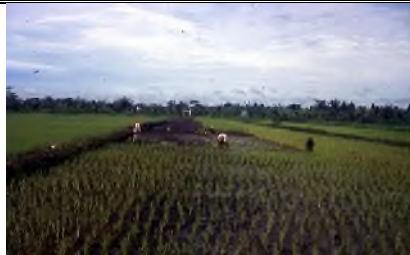
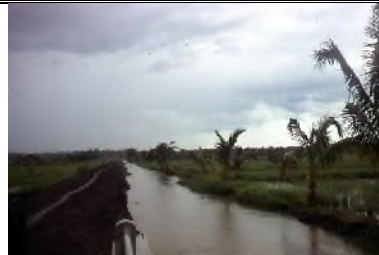
D3 4 047/D.3.4.47 Distribution structure in tertiary canal	D3 4 048/D.3.4.48 Bridge over secondary canal	D3 4 049/D.3.4.49 Transplantation of rice	D3 4 050/D.3.4.50 Dredged material from secondary canal at the bank

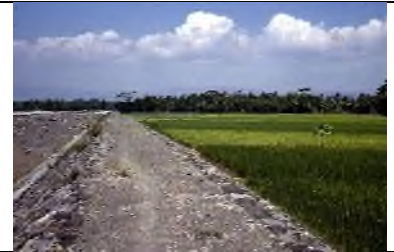
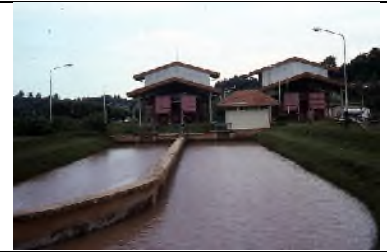
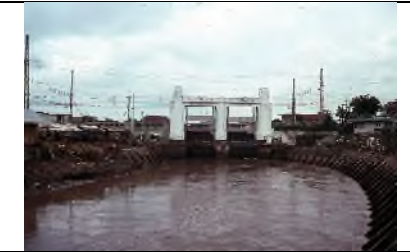
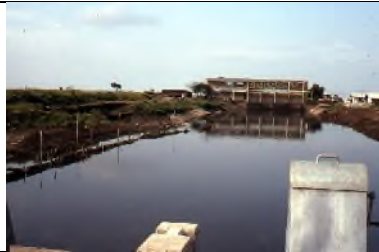
D3 4 052/D.3.4.52 Dike along lowland area	D3 4 053/D.3.4.53 Water supply to and discharge from an installation	D3 4 054/D.3.4.54 Discharge sluice	D3 4 056/D.3.4.56 Primary canal to discharge sluice, or drainage pumping station

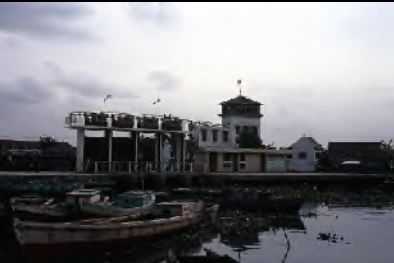
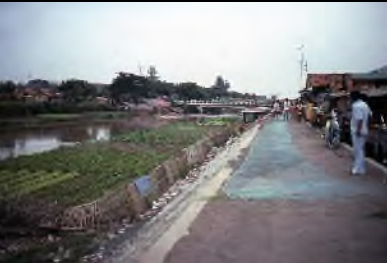
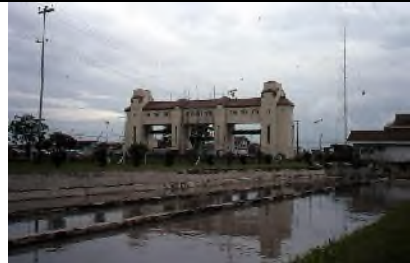
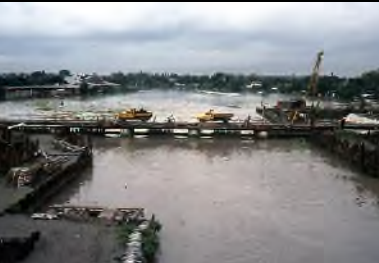
D3 4 057/D.3.4.57 Discharge sluice	D3 4 058/D.3.4.58 Dike along primary canal	D3 4 059/D.3.4.59 Discharge sluice?	D3 4 060/D.3.4.60 Bridge over primary canal

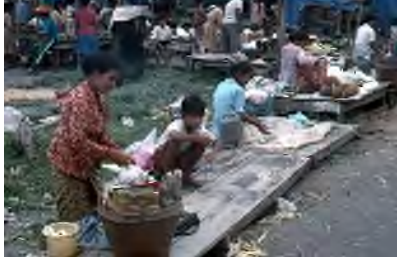
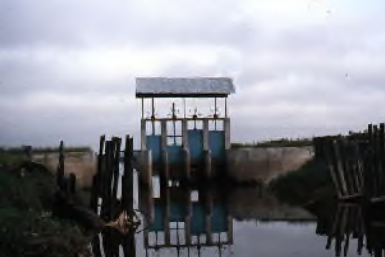
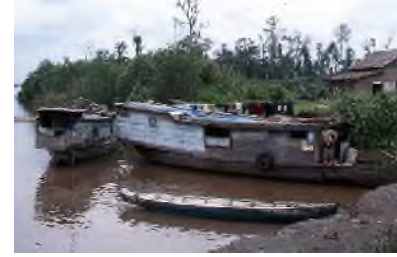
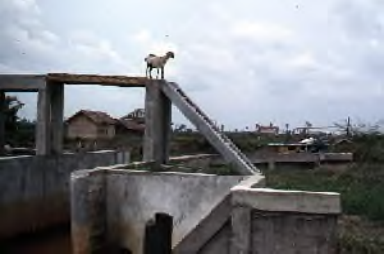
<p>D2 4 050/IV-50 Local market in a transmigrants area in the Musi Delta. 27/9-10/10 1985</p>	<p>D3 5 001/V-1 Sluice with vertical gates in lowland area Upang in the Musi Delta. 27/9-10/10 1985</p>	<p>D3 5 003/V-3 Boats for local transport in lowland area Upang in the Musi Delta. 27/9-10/10 1985</p>	<p>D3 5 004/V-4 Goat at the top of a discharge sluice in lowland area Upang in the Musi Delta. 27/9-10/10 1985</p>

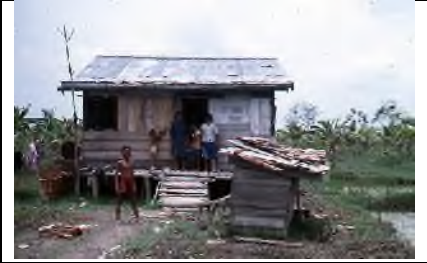
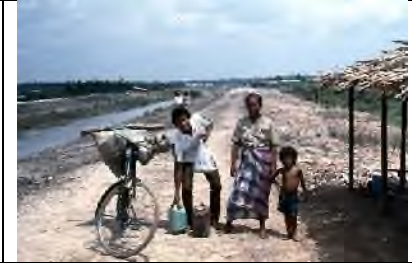
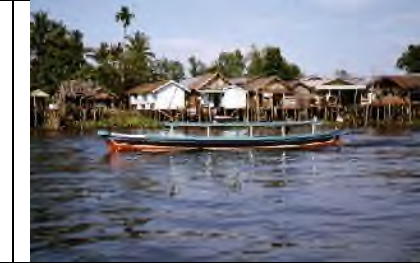
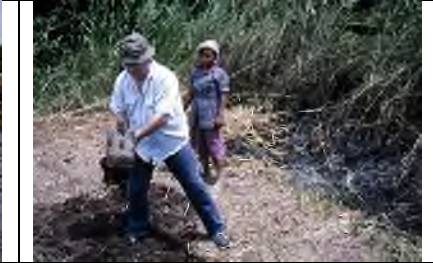
<p>D3 5 005/V-5 New transmigrants for their house in the Musi Delta. 27/9-10/10 1985</p>	<p>D3 5 008/V-8 People at a dike along a newly constructed canal in a lowland area in the Musi Delta. 27/9-10/10 1985</p>	<p>D3 5 011/V-11 Local boats at the Barito River in South Kalimantan. 31/1-9/2 1986</p>	<p>D3 5 013/V-13 Prof. Wil Segeren, former Head of the Scientific Decision of the IJsselmeerpolders Development Authority exercises soil treatment in South Kalimantan. 31/1-9/2 1986</p>

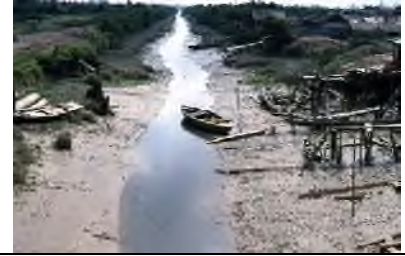
<p>D3 6 037/VI-37 Newly constructed secondary canal in the Telang area, Musi Delta, South Sumatra. 24 and 25/8 1986</p>	<p>D4 7 037/VII-37 Badly maintained secondary canal in the transmigration area Telang, Musi Delta, South Sumatra. 24/7 – 10/8 1988</p>	<p>D4 7 039/VII-39 Local transport in secondary canal in the transmigration area Telang, Musi Delta, South Sumatra. 24/7 – 10/8 1988</p>	<p>D4 7 040/VII-40 Zuurzak tree. 24/7 – 10/8 1988</p>

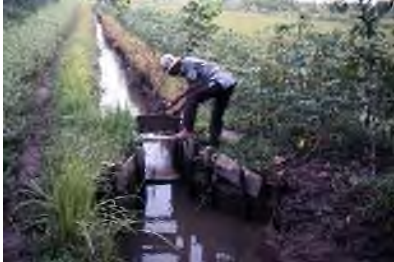
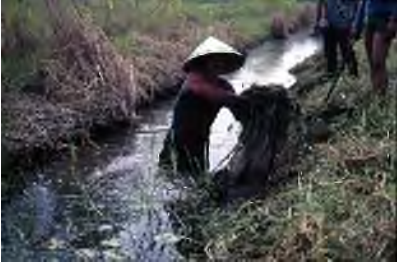
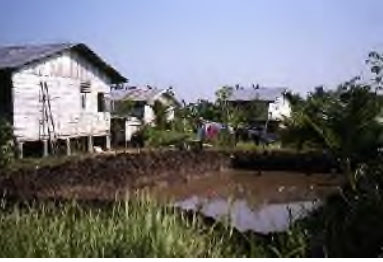
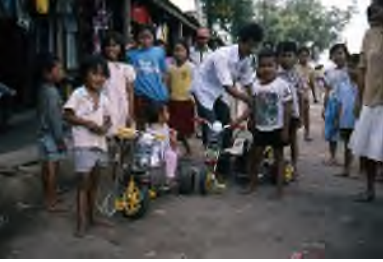
<p>D4 8 009/VIII-9 Demonstration of the operation of a weir with a vertical gate in a field canal in the transmigration area Telang, Musi Delta, South Sumatra. 24/7 – 10/8 1988</p>	<p>D4 8 011/VIII-11 Manual maintenance of a tertiary canal in the transmigration area Telang, Musi Delta, South Sumatra. 24/7 – 10/8 1988</p>	<p>D4 8 012/VIII-12 Excavation of a fishpond near a house in the transmigration area Telang, Musi Delta, South Sumatra. 24/7 – 10/8 1988</p>	<p>D4 8 015/VIII-15 Children pose for a shop in the transmigration area Telang, Musi Delta, South Sumatra. 24/7 – 10/8 1988</p>

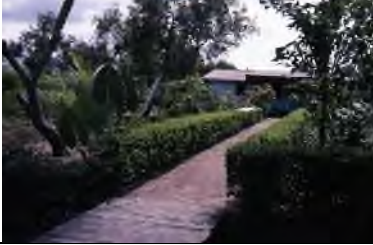
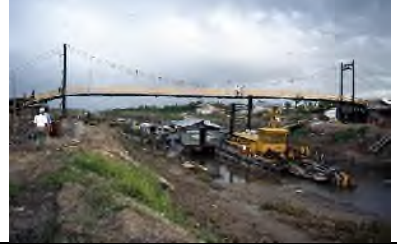
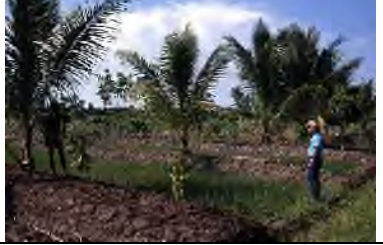
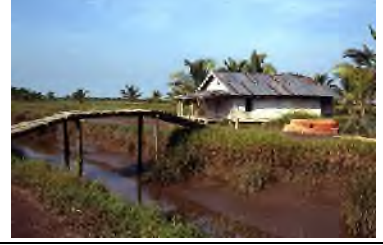
<p>D4 8 016/VIII-16 Access to the house of a local governor in the transmigration area Telang, Musi Delta, South Sumatra. 24/7 – 10/8 1988</p>	<p>D4 8 026/VIII-26 Maintenance of a primary canal in the transmigration area Saleh, Musi Delta, South Sumatra. 2 - 24/7 1989</p>	<p>D4 8 029/VIII-29 Sorjan system in the transmigration area Saleh, Musi Delta, South Sumatra. 2 - 24/7 1989</p>	<p>D5 9 011/IX-11 House along secondary canal at low tide in the transmigration area Telang, Musi Delta, South Sumatra. 28/7 – 19/8 1989</p>

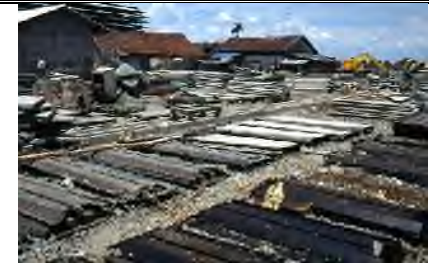
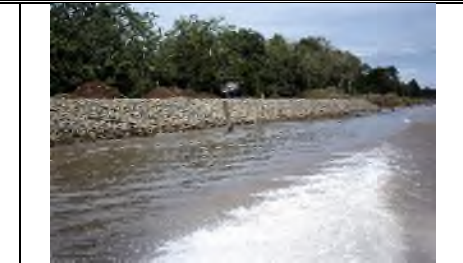
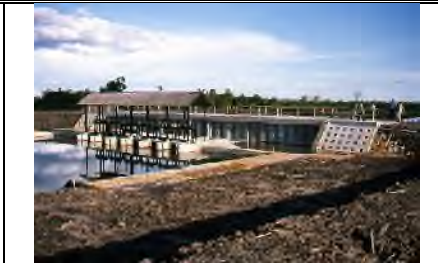
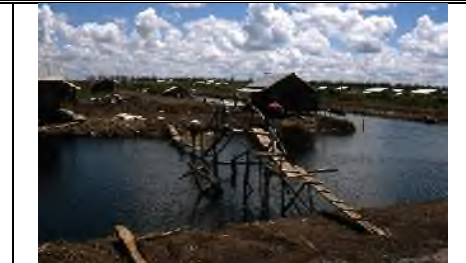
<p>D5 9 013/IX-13 Preparation and storage of prefab elements for the weirs in the tertiary canals in the transmigration areas in the Misu delta, South Sumatra. 28/7 – 19/8 1989</p>	<p>D6 11 015/XI-15 Bank protection along a primary canal in the transmigration area near Banjarmasin in Kalimantan. 23/11 – 1/12 1995</p>	<p>D6 12 008/XII-8 Discharge sluice in a large canal in South Kalimantan. 11 – 18/7 1998</p>	<p>D6 12 010/XII-10 Provisional bridge in a transmigration area in South-Kalimantan. 11 – 18/7 1998</p>

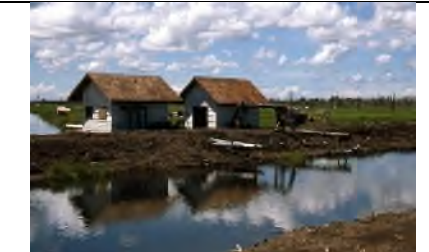
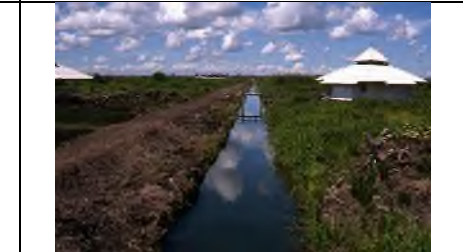
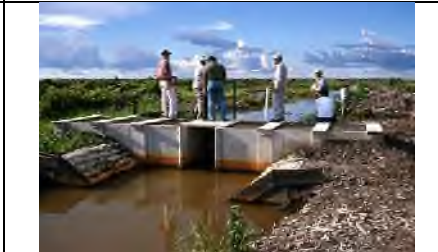
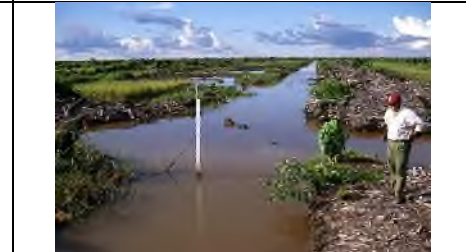
<p>D6 12 011/XII-11 Pumping station in a transmigration area in South-Kalimantan. 11 – 18/7 1998</p>	<p>D6 12 012/XII-12 Newly excavated secondary canal in a transmigration area in South-Kalimantan. 11 – 18/7 1998</p>	<p>D6 12 017/XII-17 Weir in a newly excavated secondary canal in a transmigration area in South-Kalimantan. 11 – 18/7 1998</p>	<p>D6 12 019/XII-19 Staff gauge at a crossing of a newly excavated secondary canal in a transmigration area in South-Kalimantan. 11 – 18/7 1998</p>

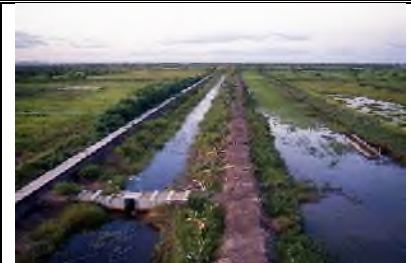
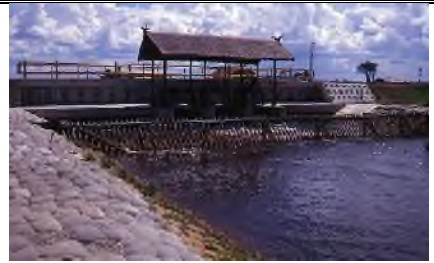
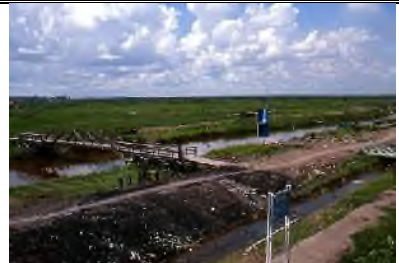
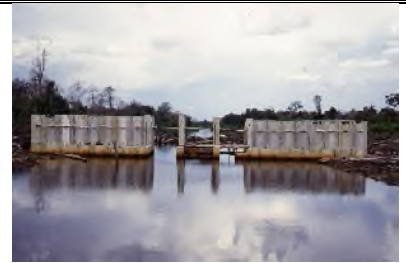
<p>D6 12 021/XII-21 Weir in a newly excavated secondary canal in a transmigration area in South-Kalimantan. 11 – 18/7 1998</p>	<p>D6 12 024/XII-24 Discharge sluice in a large canal in South Kalimantan. 11 – 18/7 1998</p>	<p>D6 12 028/XII-28 Bridge over a newly excavated secondary canal in a transmigration area in South-Kalimantan. 11 – 18/7 1998</p>	<p>D6 12 033/XII-33 Construction of a discharge sluice in a large canal in South Kalimantan. 11 – 18/7 1998</p>

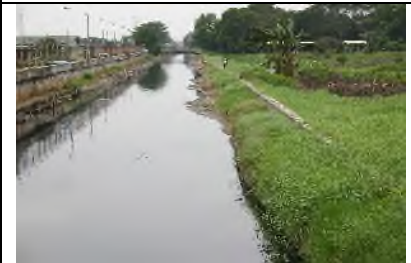
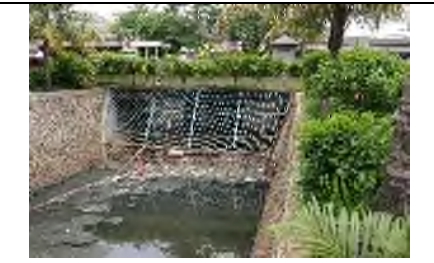
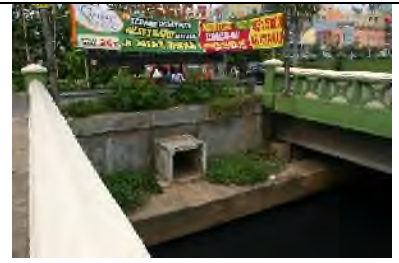
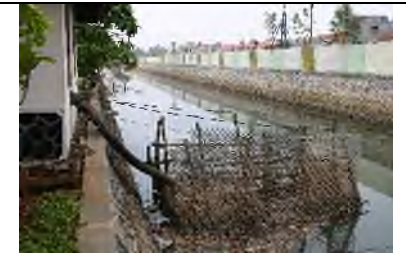
<p>114_1427 Kali Sunter, the canal where part of the excess water of the Kelapa Gading Polder is being pumped out. 1 April 2006</p>	<p>114_1430 Trash rack in front of one of the pumping stations that pump the excess water of Kelapa Gading Polder to Kali Sunter. 1 April 2006</p>	<p>114_1433 Discharge point of the pumping stations that pump out the excess water of Kelapa Gading Polder to Kali Sunter. 1 April 2006</p>	<p>114_1437 Water withdrawal from Kali Sunter. 1 April 2006</p>

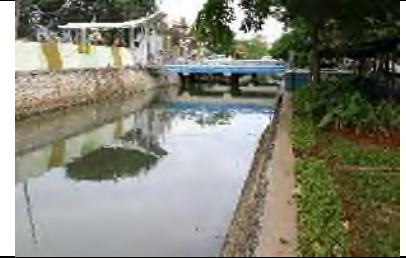
<p>114_1438 View on Kali Sunter. 1 April 2006</p>	<p>114_1439 Gates at the discharge point of a pumping station that pumps out the water of Kelapa Gading Polder to Kali Sunter. 1 April 2006</p>	<p>114_1442 Polluted water and bank erosion in Kali Sunter. 1 April 2006</p>	<p>114_1443 Pollution in front of a culvert in one of the canals of the Kelapa Gading Polder. 1 April 2006</p>

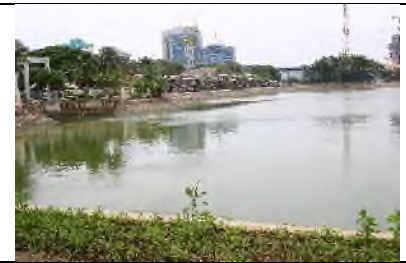
<p>114_1447 Storage pond for the separated part of the polder that is under responsibility of the navy. 1 April 2006</p>	<p>114_1451 Vegetation in a canal in the Kelapa Gading polder. 1 April 2006</p>	<p>114_1454 Houses along the canal along the east side of Kelapa Gading Polder. 1 April 2006</p>	<p>114_1455 Drain along the central boulevard in the Kelapa Gading Polder. 1 April 2006</p>

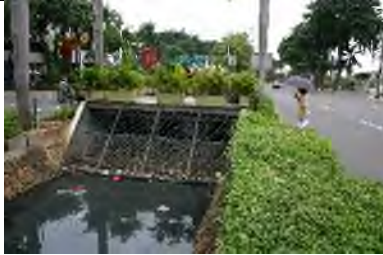
<p>114_1456 Trash rack in front of a culvert in Kelapa Gading Polder. 1 April 2006</p>	<p>114_1459 Drain in Kelapa Gading Polder. 1 April 2006</p>	<p>114_1460 Vertical gate in a drain in Kelapa Gading Polder. 1 April 2006</p>	<p>114_1462 Water hyacints in the drain to Kali Pertukangan. 1 April 2006</p>

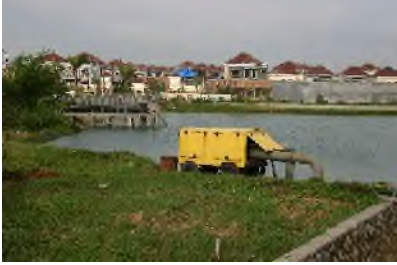
<p>114_1465 Polluted urban drain in Kelapa Gading Polder. 1 April 2006</p>	<p>114_1467 Culverts at the downstream side of a drain in Kelapa Gading Polder. 1 April 2006</p>	<p>114_1468 Mobile pump along a storage pond in Kelapa Gading Polder. 1 April 2006</p>	<p>IMG_3287 Cleaned tertiary canal in the example area in Telang II. 2 June 2012</p>

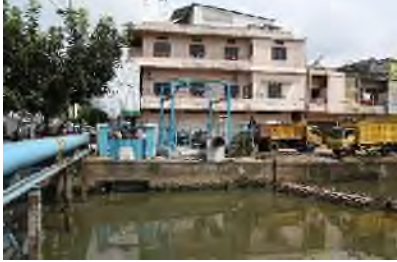
<p>IMG_3331 Outlet of a pumping station in Palembang with two lorries for the discharge of rubbish that has been removed from a canal. 6 June 2012</p>	<p>IMG_3335 Separation of rubbish near a recreation pond in the new urban quarter Jakabaring of Palembang. 6 June 2012</p>	<p>IMG_3891 Inlet for a pumping station of one of the polders in Jakarta. 25 September 2012</p>	<p>IMG_3893 Storage pond for the pumping station of one of the polders in Jakarta. 25 September 2012</p>

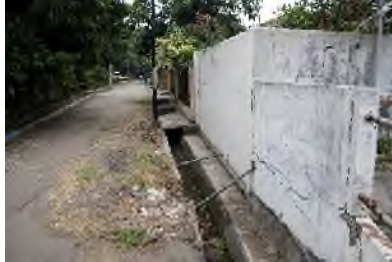
<p>IMG_3896 Discharge canal to a storage pond. This canal has insufficient discharge capacity compared to the capacity of the pumping station to pump the water to the storage pond. 25 September 2012</p>	<p>IMG_3898 Staff gauge at the inlet of a pumping station of one of the polders in Jakarta. 25 September 2012</p>	<p>IMG_3899 Concrete wall to prevent flooding from the mouth of a river near the Java Sea. 25 September 2012</p>	<p>IMG_3905 House and rubbish in the mouth of a river near the Java Sea. 25 September 2012</p>

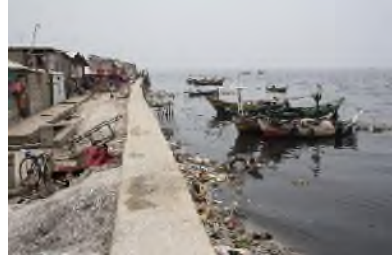
<p>IMG_3917 Concrete wall to prevent flooding from the mouth of a river near the Java Sea. 25 September 2012</p>	<p>IMG_3921 Boats at the mouth of a river near the Java Sea. 25 September 2012</p>	<p>IMG_3923 Heap of rubbish in front of a discharge sluice at the mouth of a river near the Java Sea. 25 September 2012</p>	<p>IMG_3930 Discharge sluice towards a river in Jakarta. 25 September 2012</p>

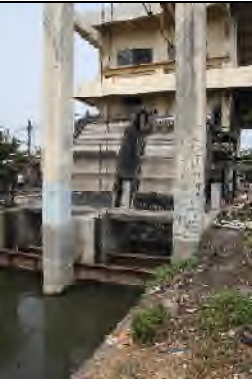
<p>IMG_3933 Pumping station in one of the canals in Jakarta where the water is pumped out to a river. 25 September 2012</p>	<p>IMG_3939 Canal towards a storage basin in Jakarta. 25 September 2012</p>	<p>IMG_3941 Rubish remover in front of the inlet of a pumping station in a polder in Jakarta. 25 September 2012</p>	<p>IMG_3945 Pollution in a canal in Jakarta. 25 September 2012</p>

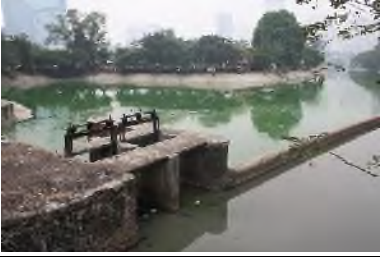
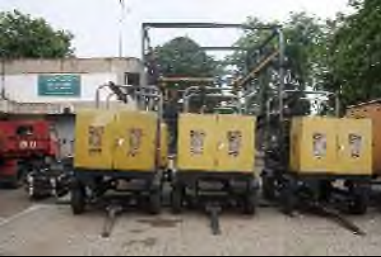
<p>IMG_3950 Removal of rubbish in front of an outlet of one of the canals in Jakarta. 25 September 2012</p>	<p>IMG_3953 Outlet of a pumping station in a canal in Jakarta. 25 September 2012</p>	<p>IMG_3958 Outlet of a canal near a storage basin in Jakarta. 25 September 2012</p>	<p>IMG_3966 Mobile pumps in a storage in Jakarta. 25 September 2012</p>

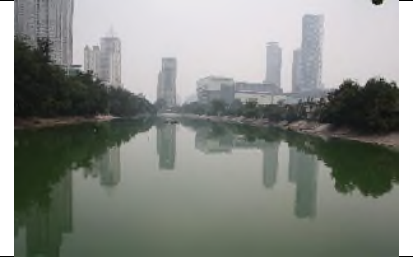
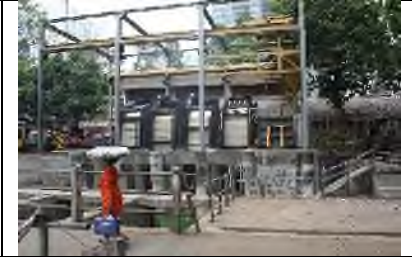
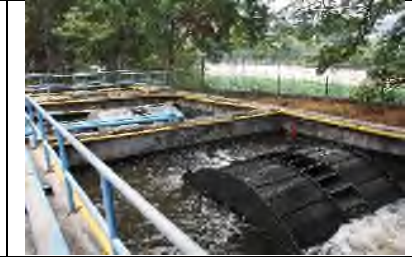
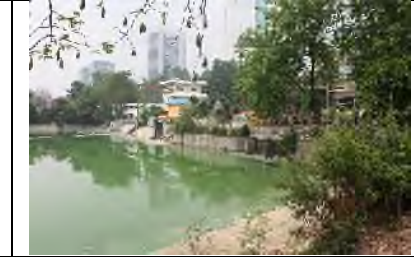
<p>IMG_3968 Storage basin in Jakarta. 25 September 2012</p>	<p>IMG_3973 Cleaning drums in front of the inlets of a pumping station for a storage basin in Jakarta. 25 September 2012</p>	<p>IMG_3979 Aerating installation in front of the outlet of water from an urban quarter near the storage basin in Jakarta. 25 September 2012</p>	<p>IMG_3992 Buildings in the higher part of a storage basin in Jakarta. 25 September 2012</p>

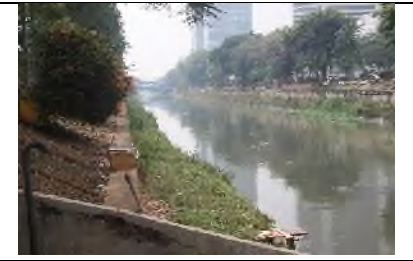
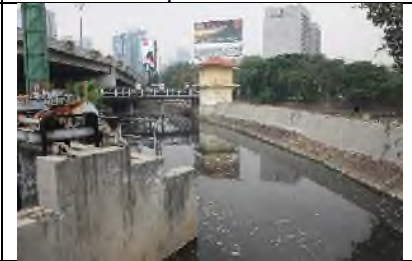
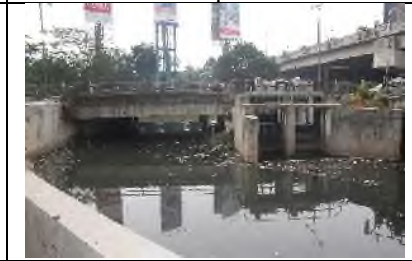
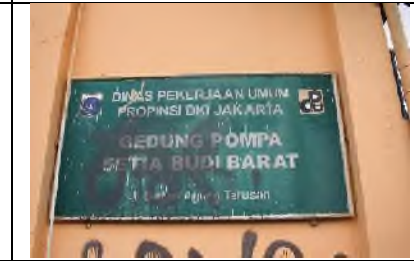
<p>IMG_3995 Canal in Jakarta. 25 September 2012</p>	<p>IMG_4005 Canal with a concrete wall to prevent flooding. 25 September 2012</p>	<p>IMG_4010 Storage basin and discharge canal of the Setia Budi Barat pumping station. 25 September 2012</p>	<p>IMG_4012 Name plate Setia Budi Barat pumping station. 25 September 2012</p>

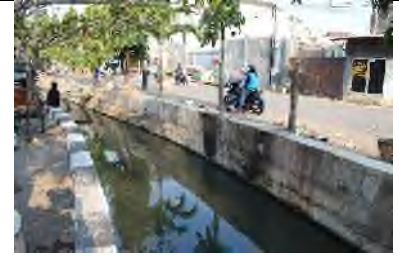
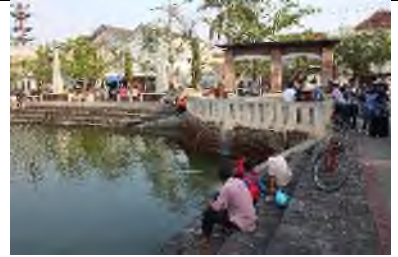
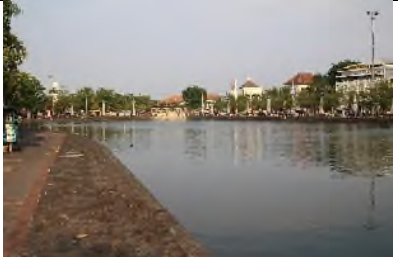
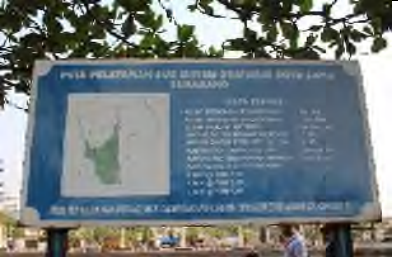
<p>IMG_2441 Discharge canal in the old quarter Kota Lama of Semarang. 16 November 2015</p>	<p>IMG_2444 Inlet to and outlet from the Tawang Storage Basin. 16 November 2015</p>	<p>IMG_2446 Tawang Storage Basin near the railway station of Semarang. 16 November 2015</p>	<p>IMG_2448 Information plate with the characteristic data of the drainage system of the old quarter Kota Lama of Semarang 16 November 2015</p>

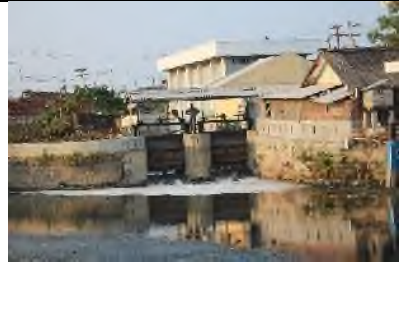
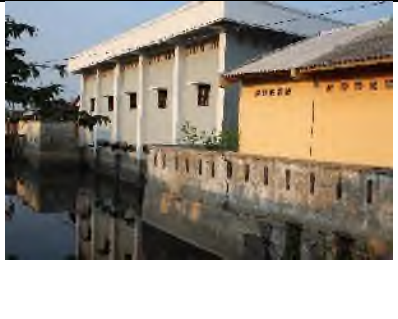
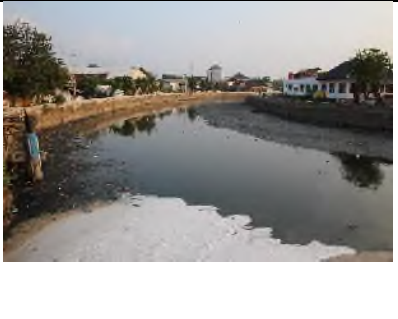
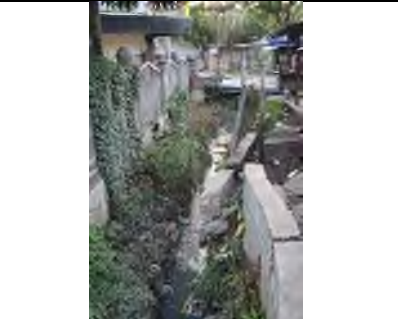
<p>IMG_2454 Vertical gates at the inlet of the right branch of the Semarang River that has been closed off near the mouth. 16 November 2015</p>	<p>IMG_2455 Pumping station behind the inlet of the right branch of the Semarang River that has been closed off near the mouth. This pumping station also pumps out the excess water of the old quarter Kota Lama of Semarang. 16 November 2015</p>	<p>IMG_2458 View at the Semarang River from the branching point in upstream direction. 16 November 2015</p>	<p>IMG_2469 Damaged and polluted canal in a housing area in Semarang. 16 November 2015</p>

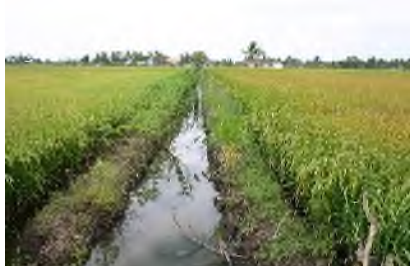
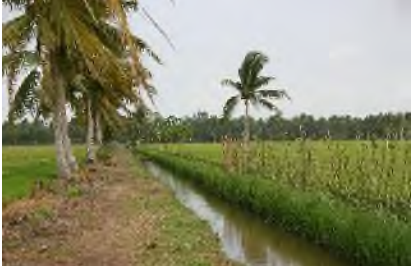
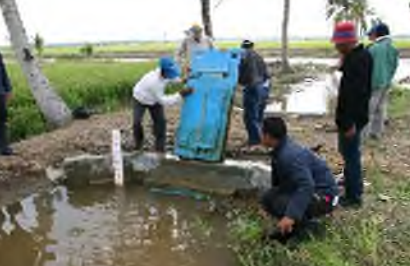
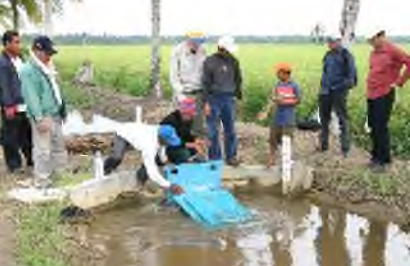
<p>103_0332 Tertiary canal between rice fields in the Telang I area. 25 January 2005</p>	<p>103_0336 Field canal along a rice field in the Telang I area. 25 January 2005</p>	<p>103_0342 Inspection of the movable fiberglass flapgate for the control of the discharge of and water supply to a tertiary canal in the Telang I area. 25 January 2005</p>	<p>103_0343 Inspection of the movable fiberglass flapgate for the control of the discharge of and water supply to a tertiary canal in the Telang I area. 25 January 2005</p>

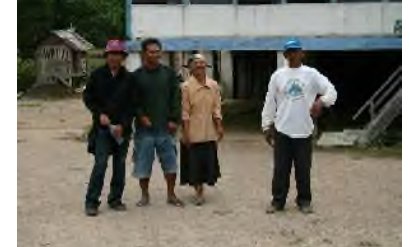
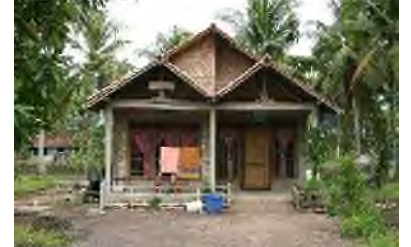
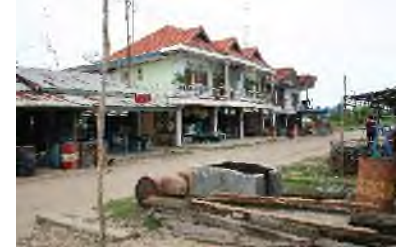
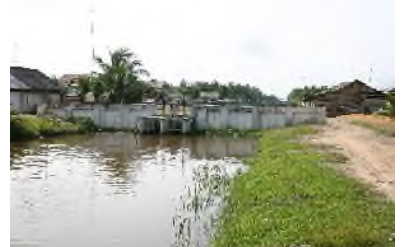
<p>103_0350 Farmer Supir, poses with his wife and sons in front of his house in the Telang I area. 25 January 2005</p>	<p>103_0352 Stone house in the Telang I area. 25 January 2005</p>	<p>103_0358 Shops at a central location in the Telang I area. 25 January 2005</p>	<p>103_0362 Water control structure at high tide for the control of the discharge of and water supply to a secondary canal in the Telang I area, Musi Delta, South Sumatra. 27 January 2005</p>

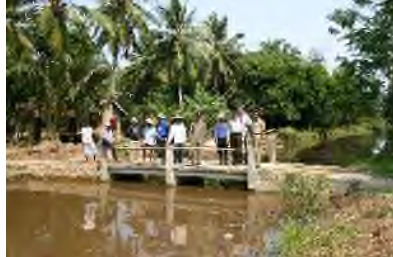
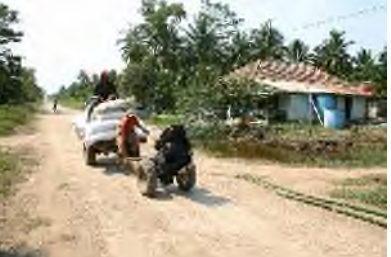
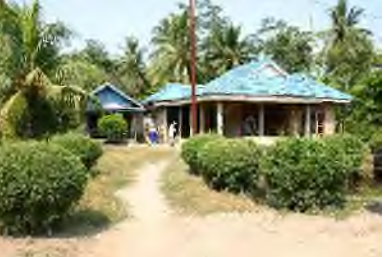
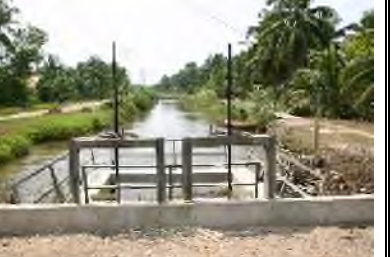
<p>103_0370 Visit to a bridge over a secondary canal that has been constructed by the local population. 27 January 2005</p>	<p>103_0374 Access road with a masonry house in the Telang I area. Transport of the harvest to the jetty for the further transport over water. 27 January 2005</p>	<p>103_0376 Masonry house in the Telang I area. 27 January 2005</p>	<p>103_0379 High tide in a secondary canal in front of the structure for the control of the discharge of and water supply to a secondary canal in the Telang I area. 27 January 2005</p>

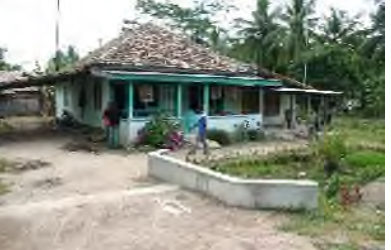
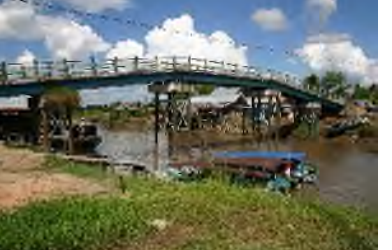
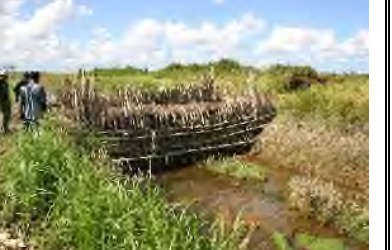
<p>107_0717 Low tide at a structure for the control of the discharge of and water supply to a secondary canal in the Telang I area. 1 August 2005</p>	<p>107_0724 Nice house in Telang I area. 1 August 2005</p>	<p>107_0726 Renovated steel Bridge over a primary canal in the Telang I area. 1 August 2005</p>	<p>107_0728 Provisorional dam in a secondary canal in the Saleh Area at low tide. 1 August 2005</p>

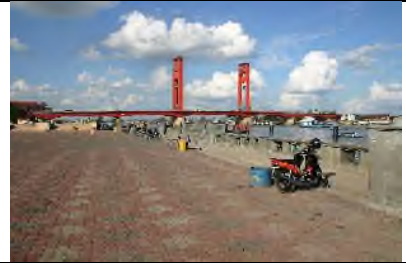
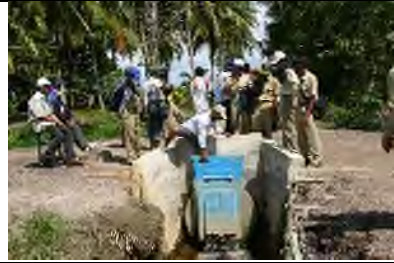
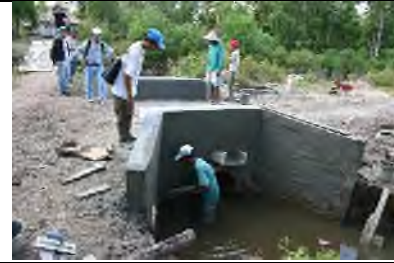
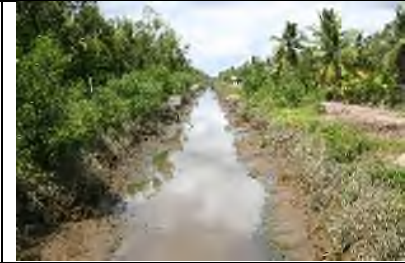
<p>107_0732 Characteristic Bridge in Palembang over the Musi River. 1 August 2005</p>	<p>107_0740 Visit to a weir with a movable fibreglas flapgate for the control of the discharge of and water supply to a tertiary canal in the Saleh area. 2 August 2005</p>	<p>107_0742 Visit to a weir with a movable fibreglas flapgate for the control of the discharge of and water supply to a tertiary canal in the Saleh area. 2 August 2005</p>	<p>107_0747 Secondary canal in the Saleh Area at low tide. 2 August 2005</p>

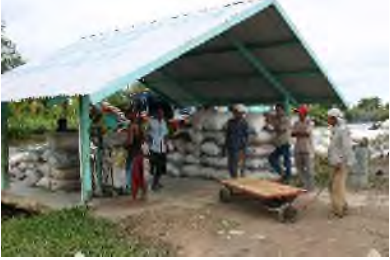
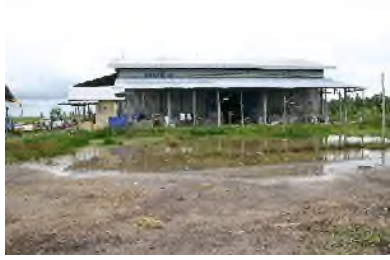
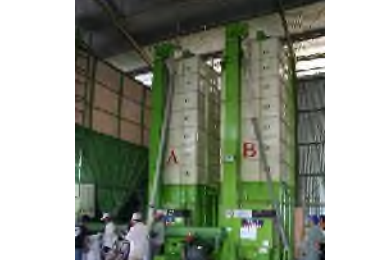
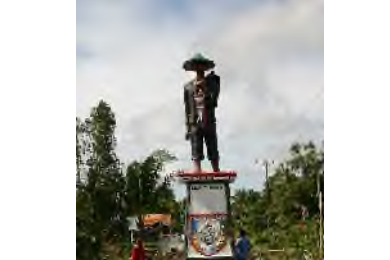
<p>113_1411 House for the receipt of rice at a drying installation. 27 March 2006</p>	<p>113_1412 Building in the Telang I area in which there are drying installations for rice. 27 March 2006</p>	<p>113_1416 Installations for the drying of rice. 27 March 2006</p>	<p>113_1420 Statue aan the entrance of Srimulyo village, Telang I area, District Banyuasin. 27 March 2006</p>

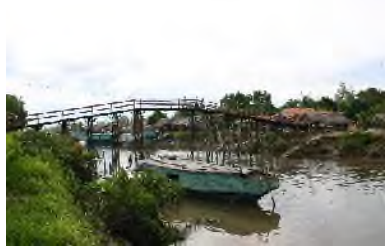
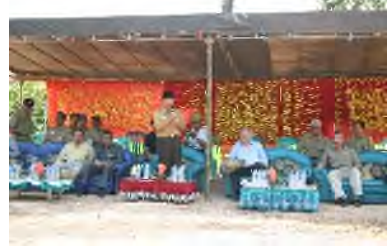
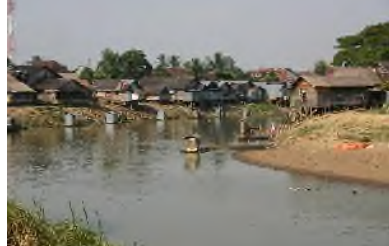
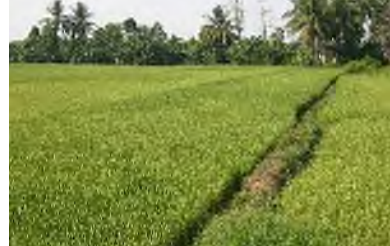
<p>113_1426 Bridge over a primary canal in the Telang I area. 27 March 2006</p>	<p>118_1809 Visit to the pilot area of the project Sustainable Development of Tidal Lowlands in South-Kalimantan. 24 August 2006</p>	<p>118_1811 Crossing of a primair and a secondary canal in a transmigration area in South-Kalimantan. 24 August 2006</p>	<p>118_1818 Nice rice field in a transmigration area in South-Kalimantan. 24 August 2006</p>

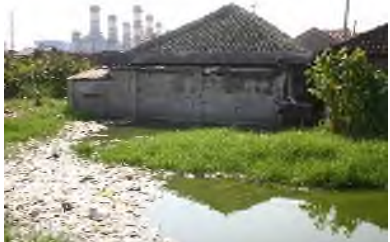
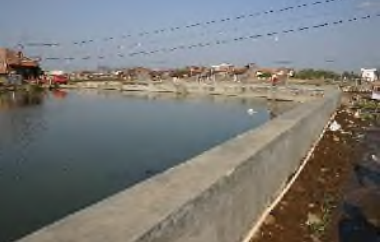
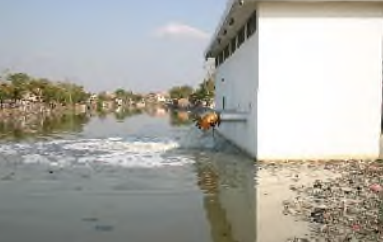
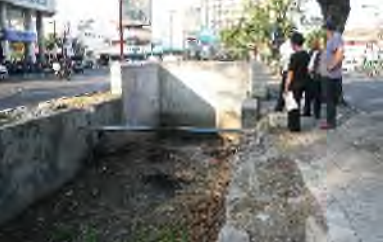
<p>127_2791 Waterlogging in the Banger Polder in Semarang along the Banger River. 4 July 2007</p>	<p>127_2794 Wall to prevent flooding along the Banger River in Semarang at high tide. The Banger Polder is located at the east side of Semarang. Due to the discharge of the Banger River in 2016 the area was still in open connection with the Java Sea. 4 July 2007</p>	<p>128_2801 Pumping station along the Banger River to pump out local water from the weatern part of Banger Polder. 4 July 2007</p>	<p>128_2809 Open drain in Banger Polder, Semarang. 4 July 2007</p>

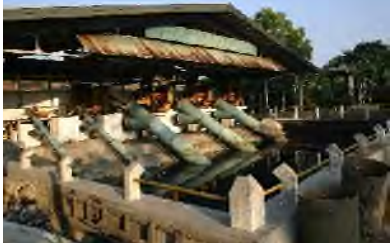
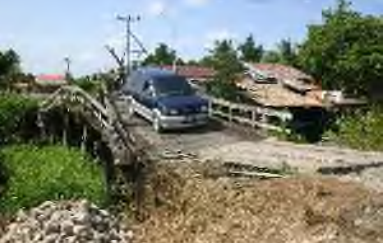
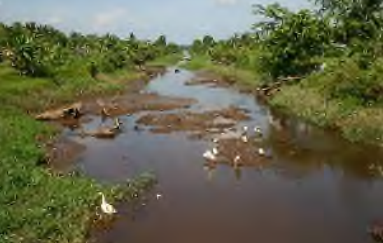
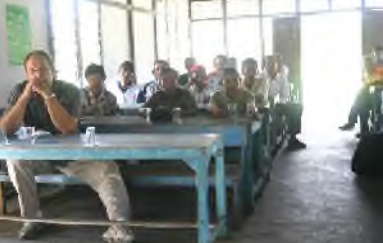
<p>128_2815 Pumping station for the pumping out of water from Semarang to the Eastern Banjir Canal. 4 July 2007</p>	<p>128_2819 Damaged bridge over a river in the Pontianak area, West Kalimantan. 7 July 2007</p>	<p>128_2820 Inadequately maintained primary canal in peatland in the Pontianak area, West Kalimantan. 7 July 2007</p>	<p>128_2823 Information to farmers over the pilot project to improve the water management in a secondary block - about 250 hectares - in the Pontianak area, West Kalimantan. Left in front Martijn Elzinga, staff member of the Civil Engineering Department of Rijkswaterstaat. 7 July 2007</p>

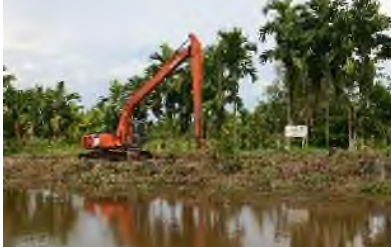
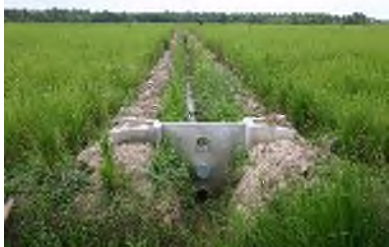
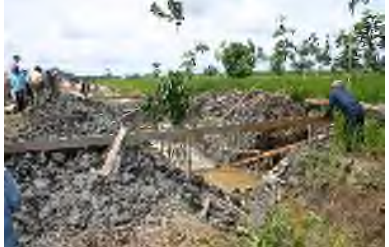
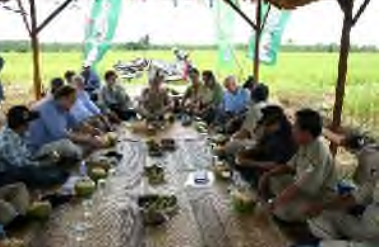
<p>IMG_3026 Hydraulic crane for the excavation of a primary canal in the Sambas area, West Kalimantan. 19 November 2007</p>	<p>IMG_3028 Weir with different options for water supply to or discharge of water from a tertiary canal in the Sambas area, West Kalimantan. 20 November 2007</p>	<p>IMG_3036 Construction of a structure for water supply to or discharge of water from a secondary canal in the Sambas area, West Kalimantan. 20 November 2007</p>	<p>IMG_3040 Meeting in the field in the Sambas area, West Kalimantan. At the head of the table the head of the Sambas District. 20 November 2007</p>

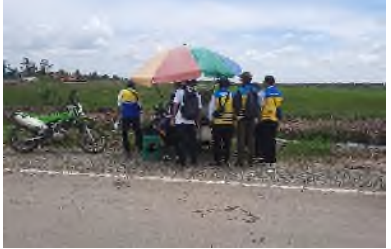
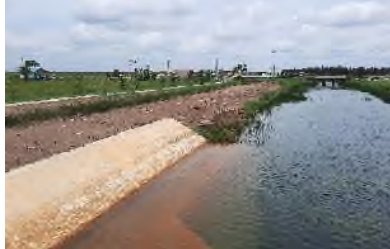
<p>20241017_132203 Open air fruitstore. Beginning of economic activity in Dadahup Polder</p>	<p>20241017_132446 Secondary canal from the inlet and outlet structure in the direction of the main canal of Dadahup Polder</p>	<p>20241017_132509 Road along the secondary canal from the inlet and outlet structure in the direction of the main canal. In the background some preliminary buildings and hydraulic cranes for reclamation of Dadahup Polder</p>	<p>20241017_132647 Staff gauge at the inlet and outlet structure in the secondary canal in the direction of the main canal of Dadahup Polder</p>

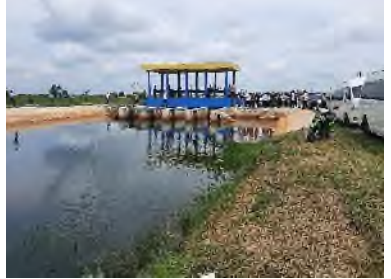
<p>20241017_132822 Inlet and outlet structure at the inside of a secondary canal in Dadahup Polder</p>	<p>20241017_132832 Secondary canal in Dadahup Polder</p>	<p>20241017_132855 Landscape in Dadahup Polder with a tertiary canal in front and hydraulic cranes for reclamation of Dadahup Polder at the background</p>	<p>20241017_132907 Landscape in Dadahup Polder with a tertiary canal and road</p>

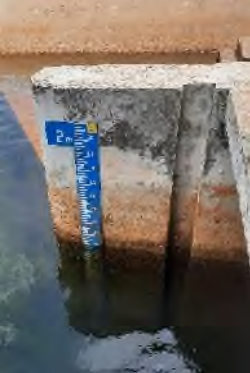
<p>20241017_133019 Landscape in Dadahup Polder with a tertiary canal and in the background some preliminary buildings and hydraulic cranes for reclamation of Dadahup Polder</p>	<p>20241017_133213 Staff gauge at the inner side of the inlet and outlet structure of a secondary canal in Dadahup Polder</p>	<p>20241017_141809 Display of the Ministry of Public Works and companies involved in the reclamation of Dadahup Polder</p>	<p>20241017_141928 Office building of the Ministry of Public Works in Dadahup Polder</p>

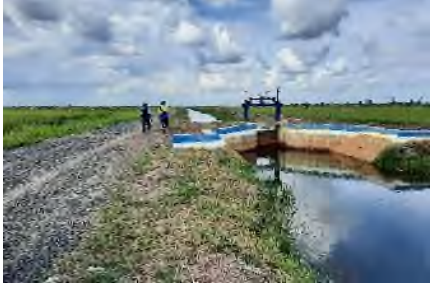
<p>20241017_145856 Inlet and outlet structure of a tertiary canal in Dadahup Polder at the side of the secondary canal</p>	<p>20241017_145913 Tertiary canal in Dadahup Polder</p>	<p>20241017_150011 Inlet and outlet structure of a tertiary canal in Dadahup Polder at the side of the tertiary canal</p>	<p>20241017_150057 Staff gauge at the inside of the inlet and outlet structure of a tertiary canal in Dadahup Polder at the side of the tertiary canal</p>

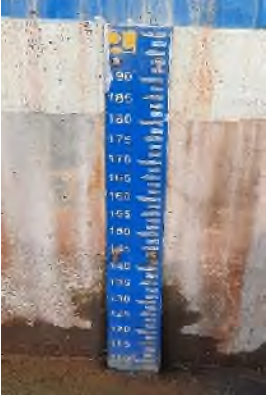
<p>20241017_150105 Staff gauge at the inside of the inlet and outlet structure of a tertiary canal in Dadahup Polder at the side of the tertiary canal</p>	<p>20241017_150655 Structure for opening and closing the inlet and outlet structure of a tertiary canal in Dadahup Polder</p>
